LUFTDYKTIGHETSPÅBUD (LDP)

Motordrevne luft-
fartøy
Bellanca-1 b
Erstatter Bellanca 1a

3/78 FARTSBEGRENSNING/SKIFTE AV FREMRE STENDER

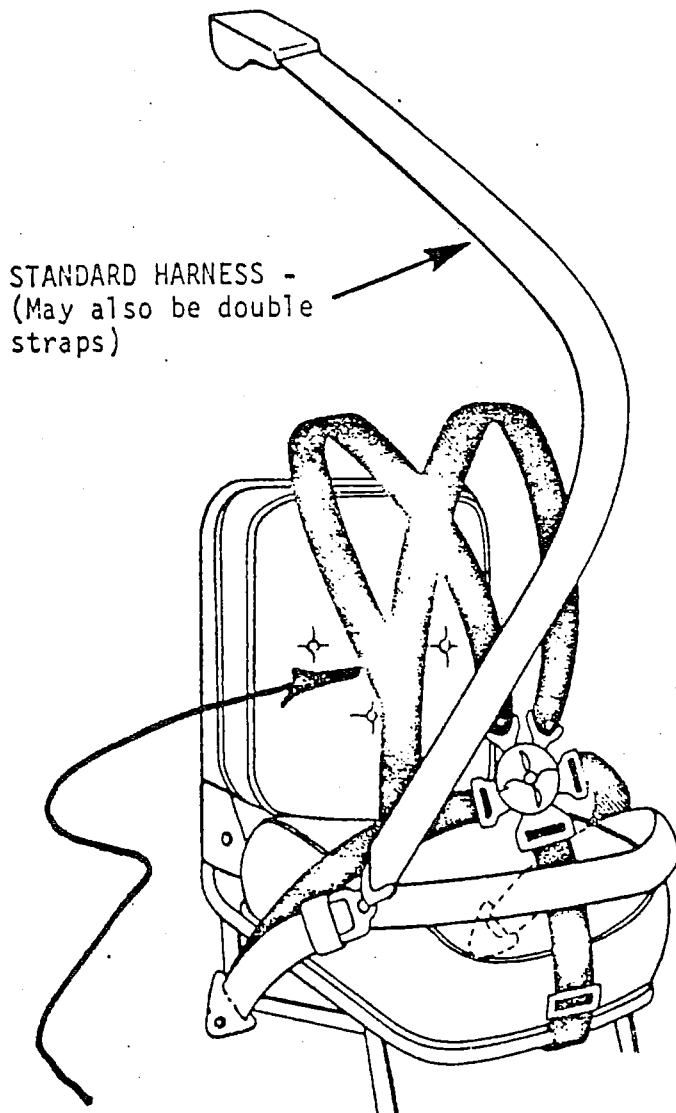
Figure I
AD 81-16-04

DO NOT ALLOW SHOULDER HARNESS TO RUN UP BEHIND THE FRONT SEAT BACK WHERE IT MAY POSSIBLY INTERFERE WITH REAR STICK MOVEMENT.

STANDARD HARNESS -
(May also be double
straps)

SUPPLEMENTAL ACRO HARNESS
(Shoulder Straps must be
on forward side of seat
back)

1. Sett inn "Figure I" i denne LDP i den godkjente flygehåndboken Flight Manual).
2. Fest "Figure I" til alle "Operating Limitation Instructions" (gult kort) i modeller hvor Flight Manual ikke er påbudt (modell 7 serien).
3. Kontroller at skulderstroppene på konkuransbeltene er montert i henhold til "Figure I" og at tilleggstroppene går på forsiden av seteryggen.
