LUFTDYKTIGHETSPÅBUD

MAULE
SAMMENDRAG
1946 - 1970

LUFTDYKTIGHETSPÅBUD (LDP)

AIRWORTHINESS DIRECTIVE

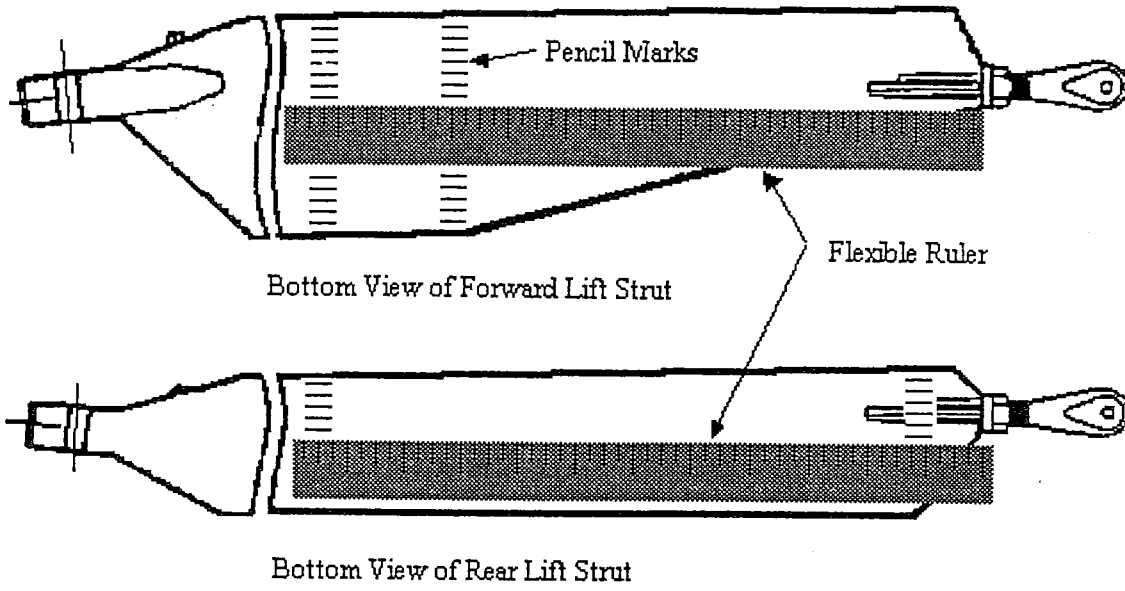
Figure 1

1. Clean the lower 18 inches of the wing lift struts using a cleaner that will remove all dirt and grease. Dirt and grease will adversely affect the accuracy of the inspection technique. Light sanding or polishing may also be required to reduce surface roughness as noted in the **EQUIPMENT REQUIREMENTS** section.

8. A measurement of 0.024 inch or less shall require replacement of the strut prior to further flight.
9. If at any time during testing an area is encountered where a valid thickness measurement cannot be obtained due to a loss of signal strength or quality, the area shall be considered suspect. These areas may have a remaining wall thickness of less than 0.020 inch, which is below the range of this setup, or they may have small areas of localized corrosion or pitting present. The latter case will result in a reduction in signal strength due to the sound being scattered from the rough surface and may result in a signal that includes echoes from the pits as well as the backwall. The suspect area(s) shall be tested with a Maule "Fabric Tester" as specified in Maule Service Bulletin No. 11, dated October 30, 1995.

10. Record the lift strut inspection in the aircraft log book.
