**LUFTFARTSVERKET**  
Hovedadministrasjonen  
Luftfartsinspeksjonen  
Postboks 8124 Dep., 0032 Oslo  
Telefon : 22 94 20 00  
Telefax : 22 94 23 91  
Tlgr. : CIVILAIR  
Telex : 71032 emb.n

**MOTORDREVNE  
LUFTFARTØY**  
**MCDONNELL DOUGLAS  
HELICOPTER- 54**  
(Forts. av HUGHES)

## **LUFTDYKTIGHETSPÅBUD (LDP)**

### **97-065      UTSKIFTING AV «TRANSMISSION OUTPUT DRIVE GEARS»**

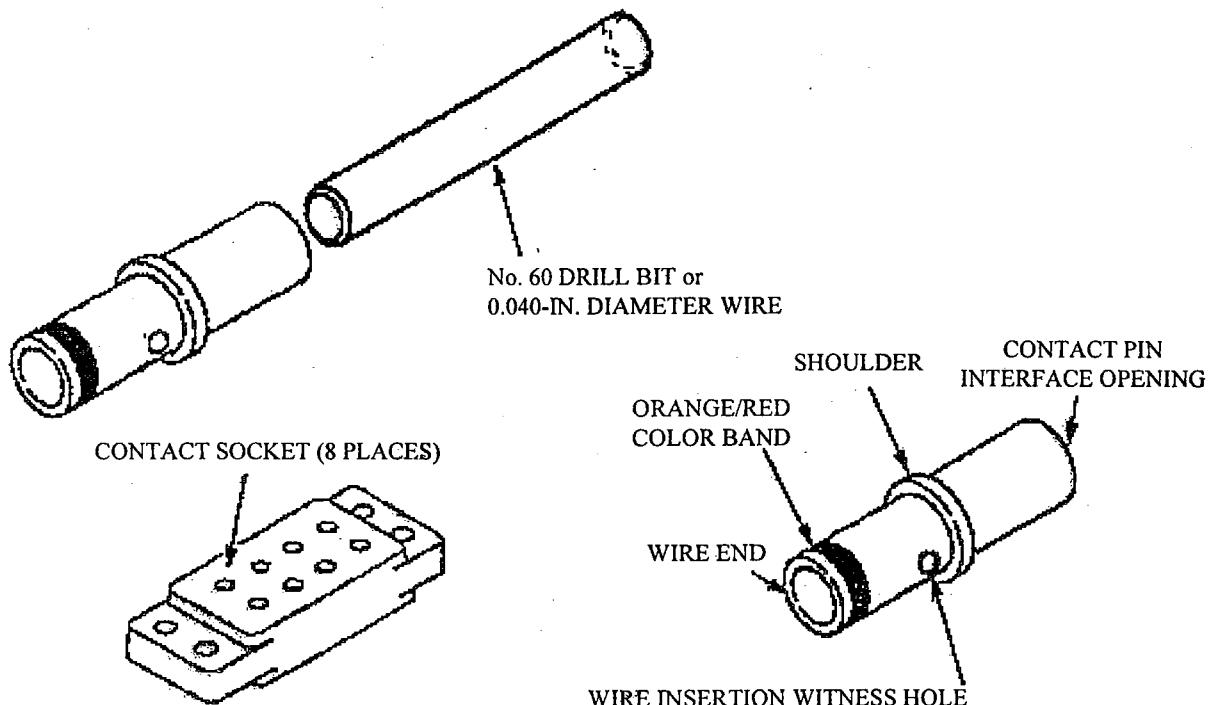
Figure 1. Contact Socket Inspection  
PL AD 98-17-14

This Priority Letter Airworthiness Directive (AD) is prompted by an incident in which a MDHS Model 600 helicopter's Engine Control Unit (ECU) Fail light illuminated, even though the ECU continued to automatically control the engine. The helicopter manufacturer reported two additional similar incidents on other Model 600N helicopters. The cause of the ECU malfunction indication was determined to be contact sockets that did not properly fit the corresponding pins of the affected relay.

This condition, if not corrected, could result in the loss of the Battery Hi Temp. relay and the Auto-Re-Ignition Igniter relay on Model 369E, 369FF, and 500N helicopters. The loss of these engine control or warning systems could result in multiple unsafe conditions, including the undetected loss of the auto-reignition function after an engine flameout, failure of an engine to reignite, and a subsequent forced landing. Also, this condition, if not corrected, could result in the undetected loss of the Battery Hi Temp. relay and the Full Authority Digital Engine Control (FADEC)-related relays (which includes the ECU Fail relay, the Engine-Out relay, the Manual Mode relay, the FADEC Start relay, and the Voice Warning Unit) on Model 600N helicopters. The undetected loss of these engine control or warning systems could result in multiple unsafe conditions, including the inability to immediately detect an engine-out condition or to properly govern main rotor speed following loss of the FADEC, and subsequent loss of control of the helicopter.

The FAA has reviewed MDHS Service Bulletin SB369E-090, SB369F-077, SB500N-017, SB600N-014, dated July 6, 1998, which describes procedures for ensuring that contact sockets properly fit the corresponding pins of the affected relay. Since an unsafe condition has been identified that is likely to exist or develop on other MDHS Model 369E, 369FF, 500N and 600N helicopters of the same type design, this AD requires, within the next 14 calendar days, inspecting each relay receptacle, part number (P/N) HS4256-1, contact sockets for correct size of the contact socket holes, and replacing incorrectly-sized contact sockets with airworthy contact sockets, P/N 019-0075-002.

- (a) Access relays K1, K2, K3, K5, K104, and K200 (relays, part number (P/N) H4240).
- (b) Remove each relay specified in paragraph (a) from its relay receptacle (receptacle).
- (c) Using a No. 60 drill bit or a 0.040-in. diameter wire as a gauge, attempt to insert the gauge into every contact socket (socket) of each relay. Ensure the gauge is inserted perpendicular to the face of the receptacle, to prevent damage to the receptacle and the socket (Figure 1). If the gauge can be inserted into a socket, it is unairworthy and must be replaced with an airworthy socket, P/N 019-0075-002.
- (d) Any replacement relay, P/N H4240, must be inspected prior to further flight, in accordance with paragraph (c) of this AD.

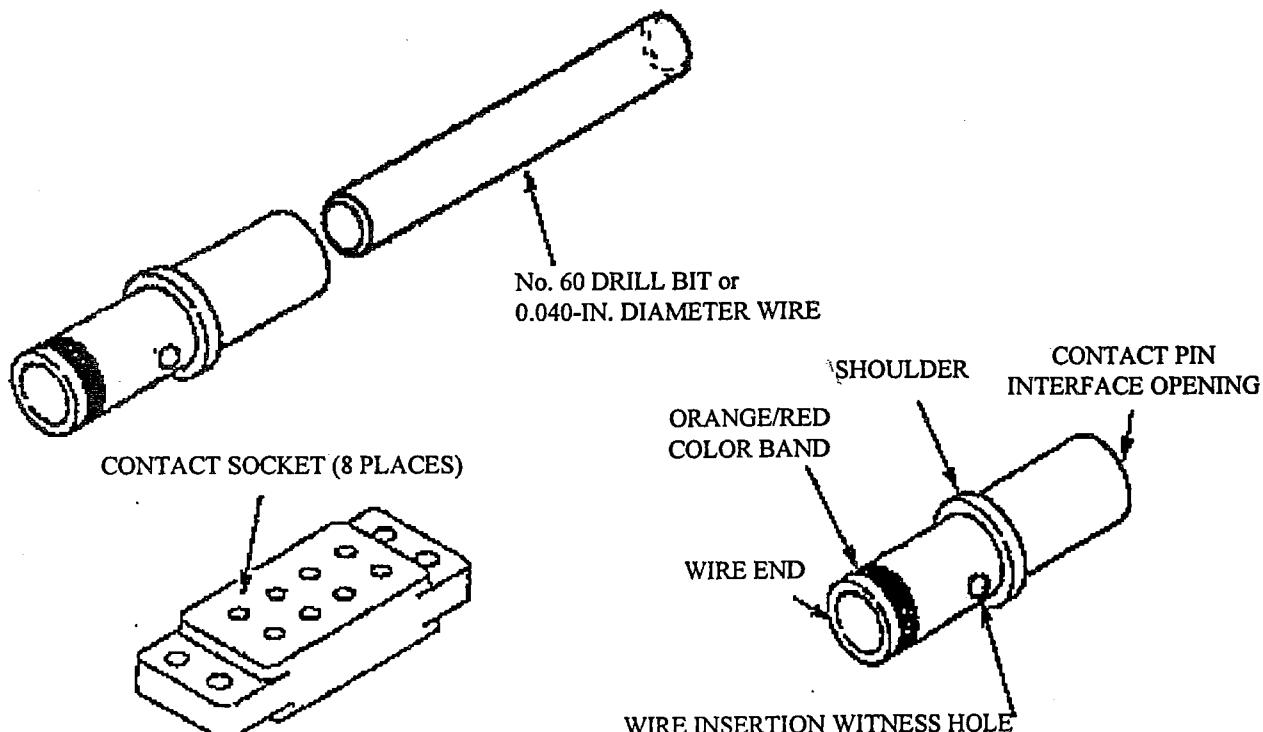
Figure 1. Contact Socket Inspection  
AD 99-08-07

To prevent undetected loss of engine control or warning systems, accomplish the following:

- (a) Access relays K1, K2, K3, K5, K104, and K200 (relays, part number (P/N) HS4240).
- (b) Remove each relay specified in paragraph (a) from its relay receptacle (receptacle), P/N HS4256-1.
- (c) Using a No. 60 drill bit or a 0.040-in. diameter wire as a gauge, attempt to insert the gauge into every contact socket (socket) of each relay. Ensure the gauge is inserted perpendicular to the face of the receptacle, to prevent damage to the receptacle and the socket (Figure 1). If the gauge can be inserted into a socket, it is unairworthy and must be replaced with an airworthy socket, P/N 019-0075-002.

(d) Any replacement relay, P/N HS4240, must be inspected prior to further flight, in accordance with paragraph (c) of this AD.

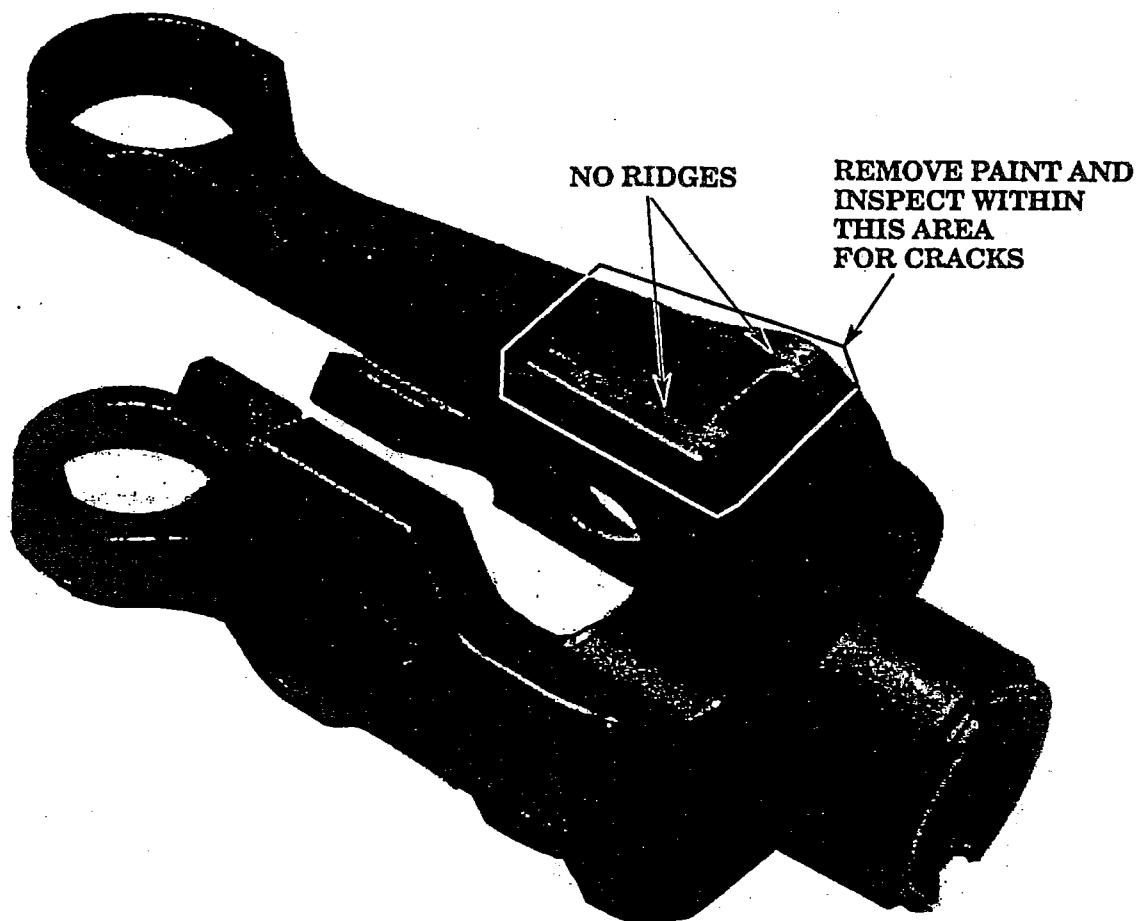
This Priority Letter Airworthiness Directive (AD) is prompted by reports from the manufacturer of the discovery of a discrepant part. During the manufacturing process, an unknown number of certain four-bladed tail rotor fork (fork) assemblies were incorrectly machined in critical areas after the shot-peening process. The two ridges on each of the arms of the fork assemblies were incorrectly machined off. This condition, if not corrected, could result in failure of certain fork assemblies, which could cause loss of a tail rotor blade and subsequent loss of control of the helicopter.

To prevent failure of the fork assembly, P/N 369D21701-21, which can result in loss of a tail rotor blade and subsequent loss of control of the helicopter, accomplish the following:

(1) If ridges are found, no further action is required by this AD.

(2) If no ridges are found, chemically remove paint from the machined areas, inspect the fork assembly for a crack using the dye-penetrant procedure of MIL-STD-6866 or ASTM-E1417, and conduct a visual inspection using a 10X or higher magnifying glass. (See Figure 1, sheets 1 and 2.) Replace a cracked fork assembly with an airworthy fork assembly. A fork assembly without ridges, P/N 369D21701-21, may not be installed.

(b) Thereafter, at intervals not to exceed 50 hours time-in-service (TIS), visually inspect each fork assembly without ridges, P/N 369D21701-21, for a crack using a 10X or higher magnifying glass. (See Figure 1, sheets 1 and 2.) If a crack is found, replace the cracked fork assembly with an airworthy fork assembly. A fork assembly without ridges, P/N 369D21701-21, may not be installed.

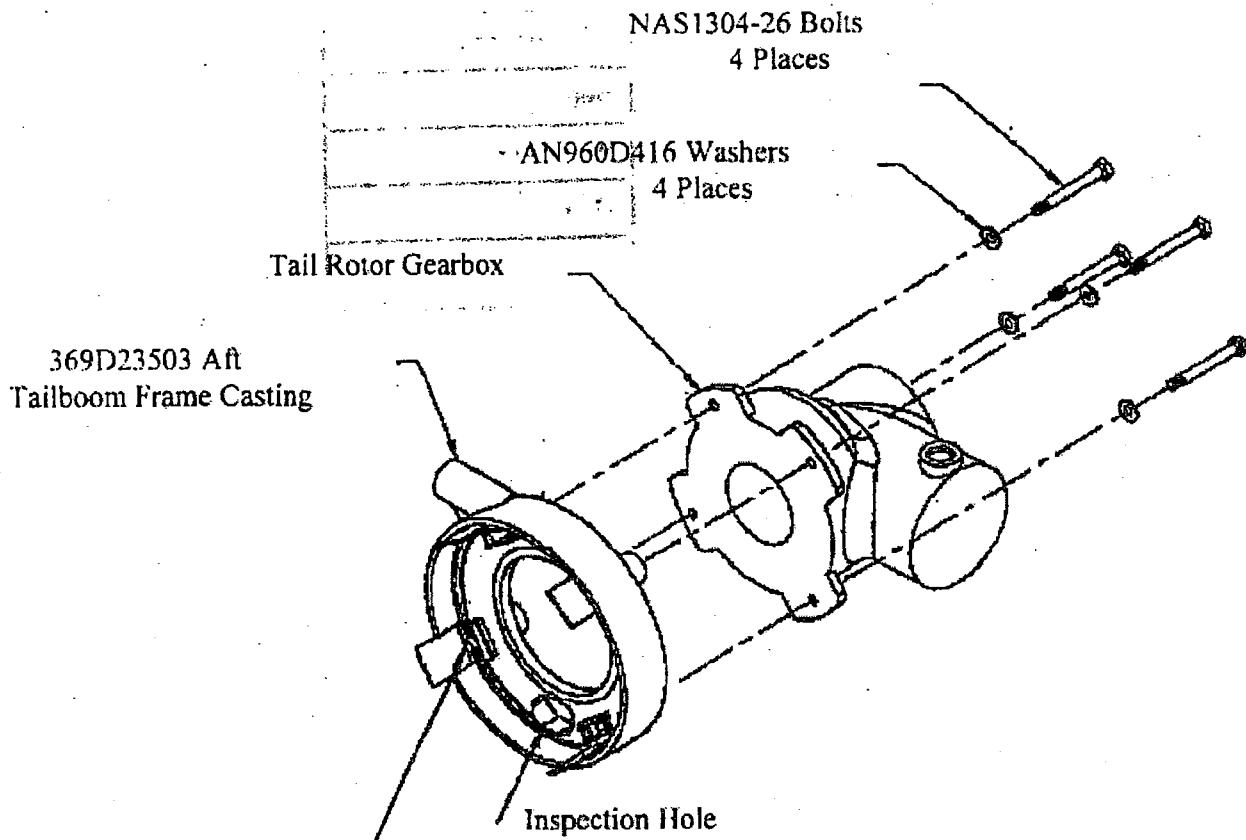
To prevent loss of the tail rotor gearbox due to attaching bolts of inadequate grip length and subsequent loss of control of the helicopter, accomplish the following:

Inspect this area of each bolt.

Bolt must protrude at least one thread past end of nutplate 4 places.

- (a) Within 25 hours time-in-service (TIS):
  - (1) For each tail rotor gearbox attaching bolt (bolt):
    - (i) Determine the part number (P/N).  
(ii) If the P/N cannot be determined or if the bolt is not P/N NAS1304-26, before further flight, replace the bolt with bolt, P/N NAS1304-26.  
(iii) Torque the bolt to 100-110 in-lbs and apply a slippage mark.
    - (2) Remove the tailboom control rod and determine the number of bolt threads protruding from each nutplate on the internal surface of the aft tailboom frame casting, P/N 369D23503, as shown in Figure 1 of this AD. At least one thread must protrude. If more than four threads protrude, add an additional washer, P/N AN960D416, under the bolt head. Torque the bolt to 100-110 in-lbs, and reapply a slippage mark. See Figure 1:
