LUFTDYKTIGHETSPÅBUD (LDP)

MOTORDREVNE
LUFTFARTØY
SCHWEIZER - 1

97-091 KONTROLL AV HOVEDROTOR «TRANSMISSION RING GEAR»

97-23-06 SCHWEIZER AIRCRAFT CORPORATION: Amendment 39-10194. Docket No. 96-SW-05-AD.

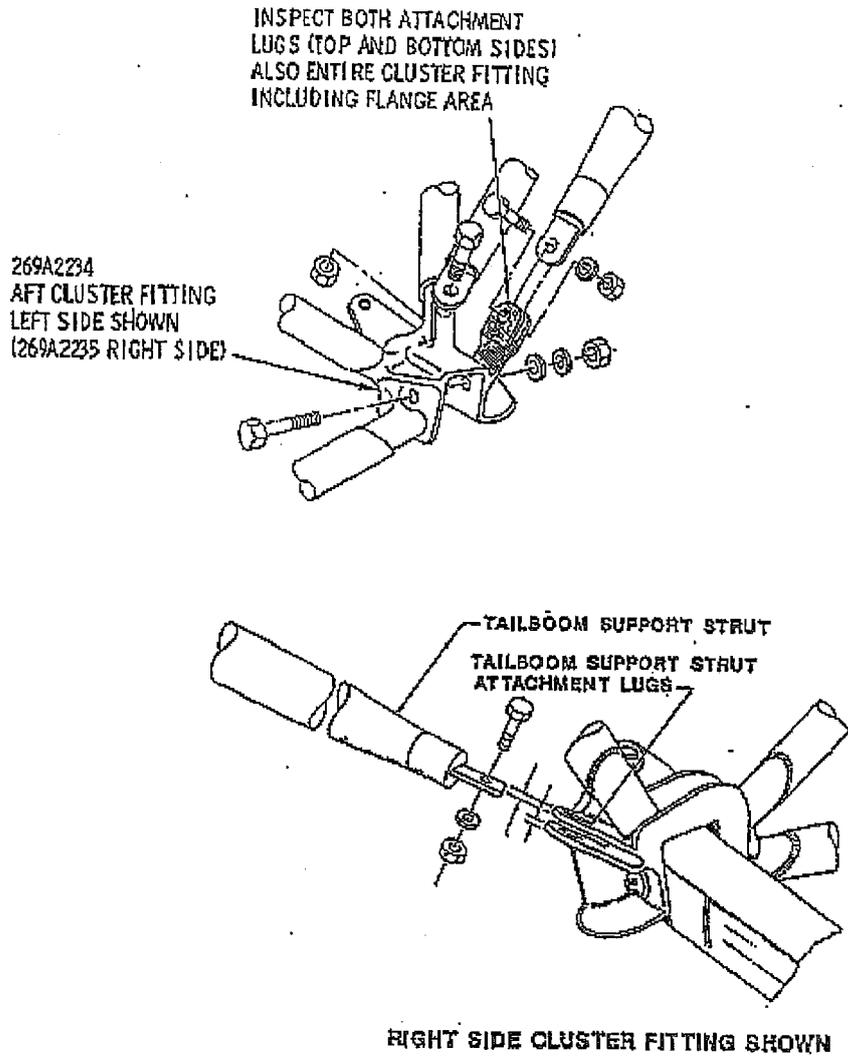
Figure 1

(2) Dye-penetrant inspect the lugs on each aft cluster fitting. See Figure 1.

(3) If a crack is found, before further flight, replace the cracked cluster fitting with an airworthy cluster fitting. Cluster fittings, P/N 269A2234 and 269A2235, are not eligible to replace a cracked cluster fitting.

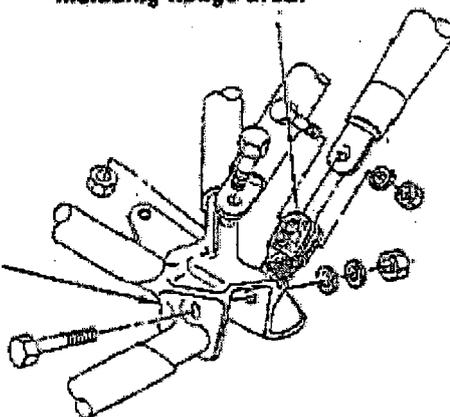
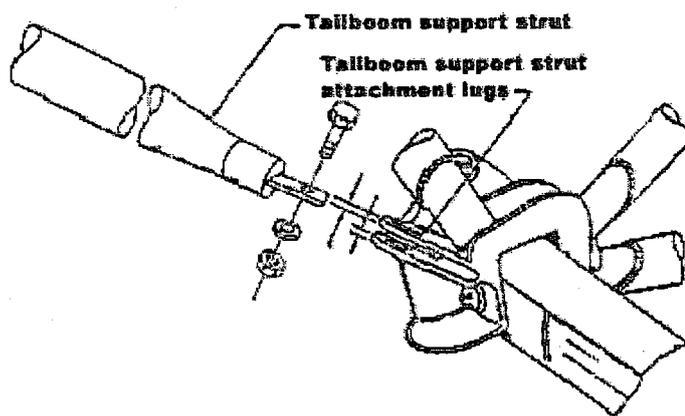
Figure 1

Inspect both attachment lugs (top and bottom sides). Also, entire cluster fitting including flange area.

**269A2234
Aft cluster fitting
Left side shown
(269A2235 right side)**

Right side cluster fitting shown

(3) If a crack is found, before further flight, replace the cracked cluster fitting with an airworthy cluster fitting.
