LUFTDYKTIGHETSPÅBUD (LDP)

MOTORDREVNE
LUFTFARTØY
SCHWEIZER - 1

97-091 KONTROLL AV HOVEDROTOR «TRANSMISSION RING GEAR»

97-23-06 SCHWEIZER AIRCRAFT CORPORATION: Amendment 39-10194. Docket No. 96-SW-05-AD.

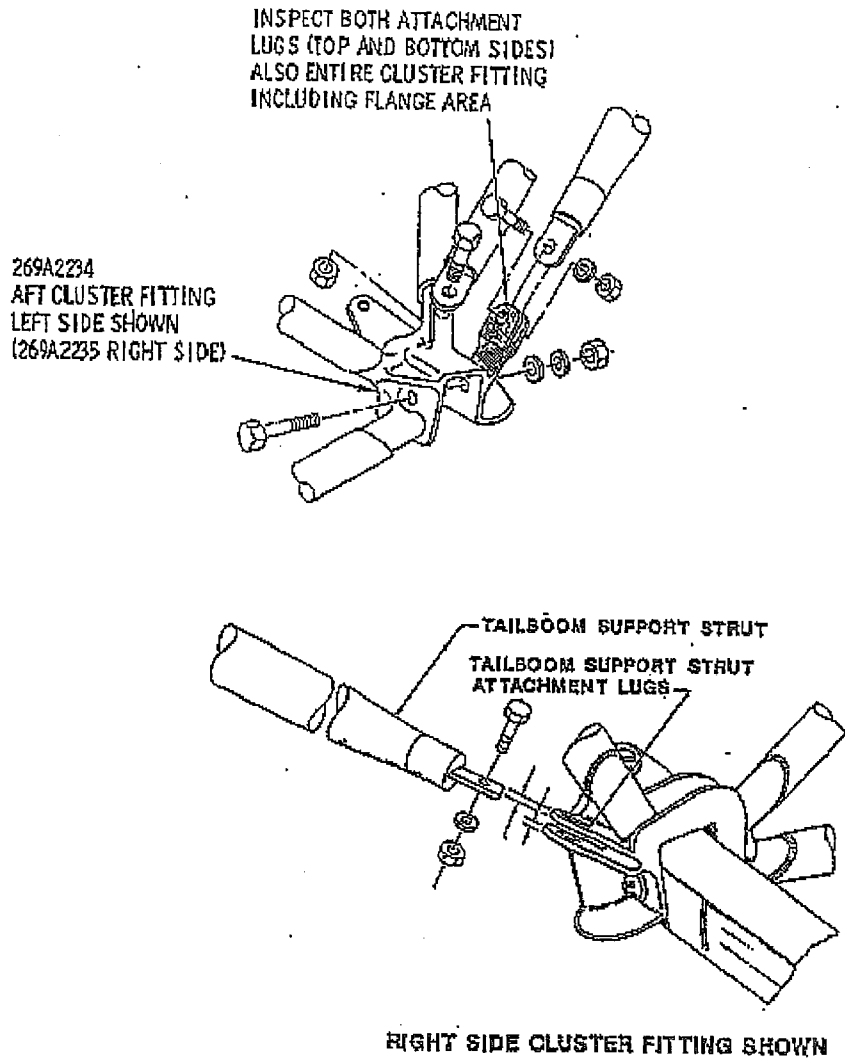
Figure 1

To prevent failure of a strut clevis lug (lug) on a center frame aft cluster fitting (cluster fitting), rotation of a tailboom into the main rotor blades, and subsequent loss of control of the helicopter, accomplish the following:

(2) Dye-penetrant inspect the lugs on each aft cluster fitting. See Figure 1.

(3) If a crack is found, before further flight, replace the cracked cluster fitting with an airworthy cluster fitting. Cluster fittings, P/N 269A2234 and 269A2235, are not eligible to replace a cracked cluster fitting.
