LUFTDYKTIGHETSPÅBUD (LDP)

SEILFLY

FFT-1
(VALENTIN)

VALENTIN - 1

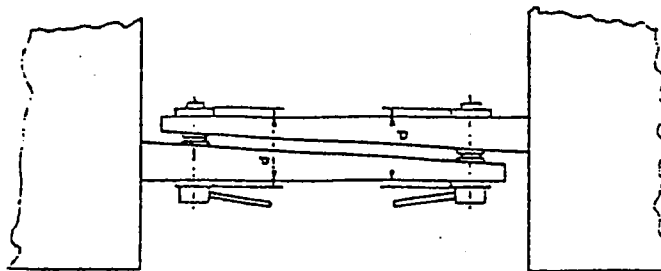
Fig. 1:

Dersom det fremkommer synlige sprekker mellom foringen og plasten, eller en relativ bevegelse kan føles med fingeren, er flyet ikke luftdyktig før pkt. 3 i denne LDP er utført.

2. Monter vingene på flyet og mål avstanden "a", ref. fig. 1, mellom foringenes ytre anleggsflater (høyre og venstre). Dersom "a" er større enn 110 mm på ett eller begge steder, er flyet ikke luftdyktig før pkt. 3 i denne LDP er utført.
3. Skift ut hovedboltforinger og monter forsterkningsplater på bjelkesteget (spar web) i henhold til FBW Job Instruction nr. 329/1.
