## LUFDDYKTIGHETSÞÅBUD (LDP)

Seilfly  
LET-1

## 99-092      INSPEKSJON AV "TAIL/FUSELAGE ATTACHMENT FITTING"

# MANDATORY BULLETIN

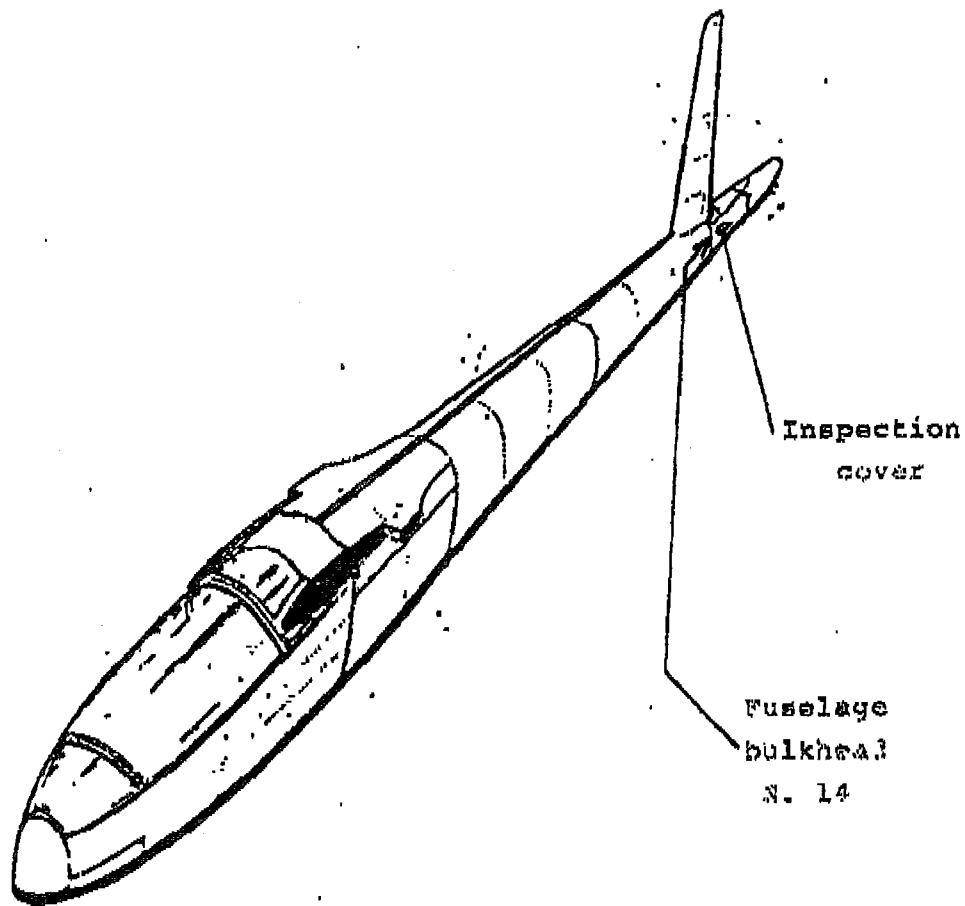
Fig. 1

**Reason:** On the L 13 BLANIK sailplane S/N 027226, the tail-fuselage attachment fitting P/N A 102 021 N made of 424253.11 material has been damaged in service.  
The material of this component must be tested as instructed in this Bulletin.

1. Remove the oval cover located on the LH side of the fuselage, under the horizontal stabilizer.
2. Test the material of the attachment fitting P/N A 102 021 N as follows:
  - a) Conductivity measurement by means of eddy currents:
    - Recommended measurement frequency: 60 kHz
    - Probe diameter: not exceeding 15 mm
    - Measuring contact point: lower milled surface of the component, between the rivets (see Figs 1 and 2).

- 3.1 If the values measured during the check are within the permissible limits specified above, make a record in the sailplane logbook (see section H of this Bulletin). The sailplane operation can be continued without any limitations.
- 3.2 If the values measured during the check are not within the permissible limits, the attachment fitting P/N A 102 021 N must be replaced before the sailplane operation can be continued.
4. If the attachment fitting P/N A 102 021 N is to be replaced, the operator shall place an order with the manufacturer, stating the sailplane Serial No., number of flight hours, registration mark, and number of its repairs and / or overhauls.
5. The manufacturer will send to the operator the material required for replacement, together with a bulletin providing the work procedure.
6. After the check, reinstall the inspection hole cover.

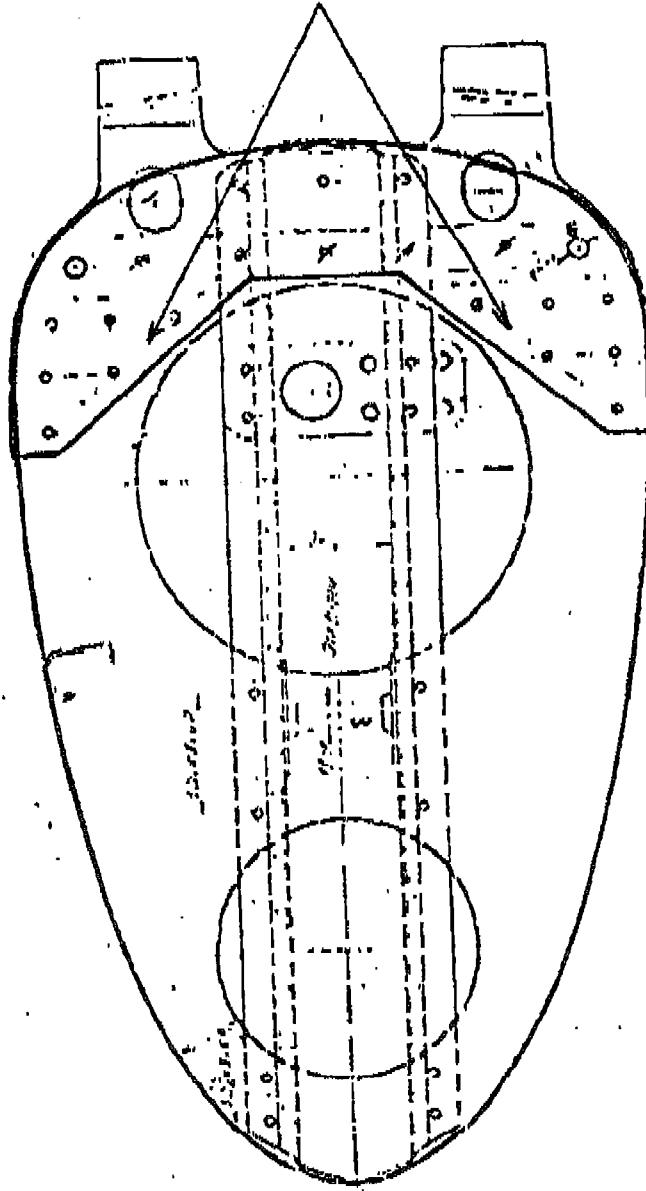
Fig. 2

Measuring contact point

Fuselage bulkhead N. 14 with attachment fitting P/N  
A 102 021 N

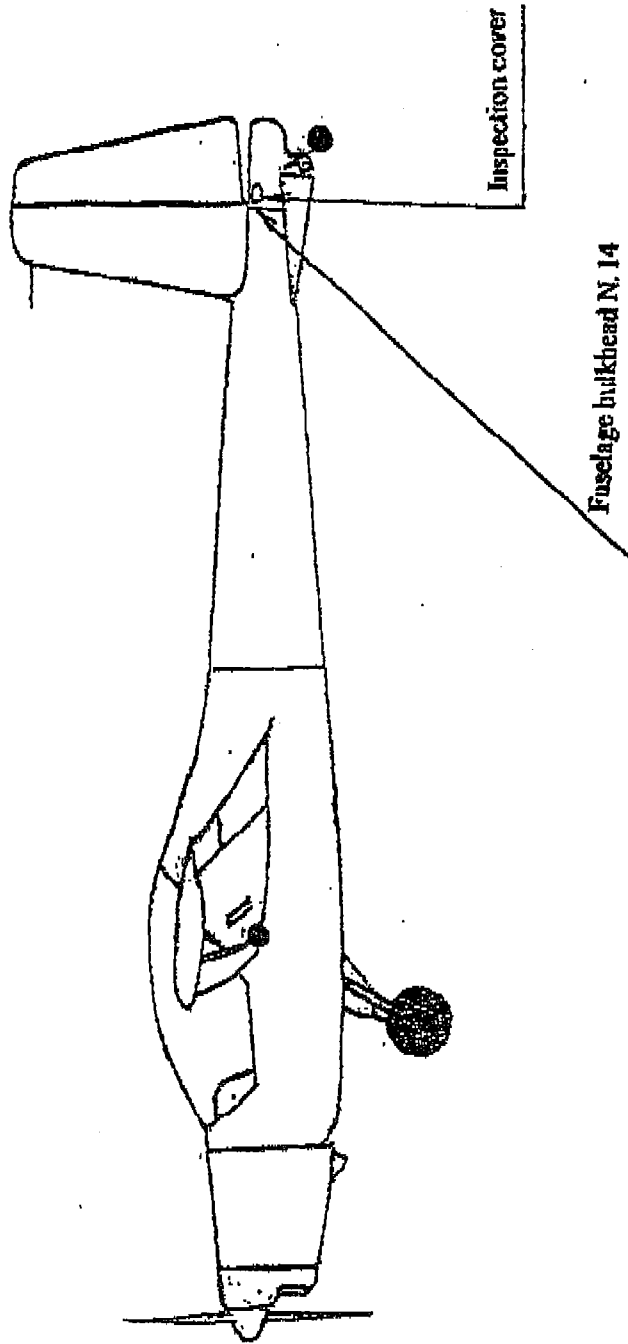
Fig. 1

1. REFER TO : All powered sailplanes No. L 13SW, L 13SE, L 13SEH, L 13SDM, L 13SL, L 13SDL.
2. REASON : On the L 13SW powered sailplane S/N 890319, the fin spar-fuselage hinge (Dwg./No. A102 021 N) made of 424253.11 material has been damaged during operation. The material of this component must be tested as instructed in this Bulletin.
3. REQUIRED ACTION : Perform the hinge material inspection.
4. LATEST DATE OF THE ACTION: After receiving this bulletin, not later than 31.12.1999.
5. ACTION CARRIED OUT BY : Operator.
6. INDUCED COST COVERED : Operator.
7. NECESSARY MATERIAL : --
8. PROCESS : See Appendix
9. ENCLOSURE: 4 sheets

1. Remove the cover located on the LH side of the fuselage, under the horizontal stabilizer.
2. Test the material of the attachment fitting P/N A 102 021N as follows:
  - a) Conductivity measurement by means of eddy currents:
    - Recommended measurement frequency: 60 kHz
    - Probe diameter: not exceeding  $\varnothing$  15 mm
    - Measuring contact point:  
lower milled surface of the component, between the rivets (see Figs 1 and 2)

2. If the values measured during the check are not within the permissible limits, the attachment fitting P/N A 102 021N must be replaced before the powered sailplane operation can be continued.

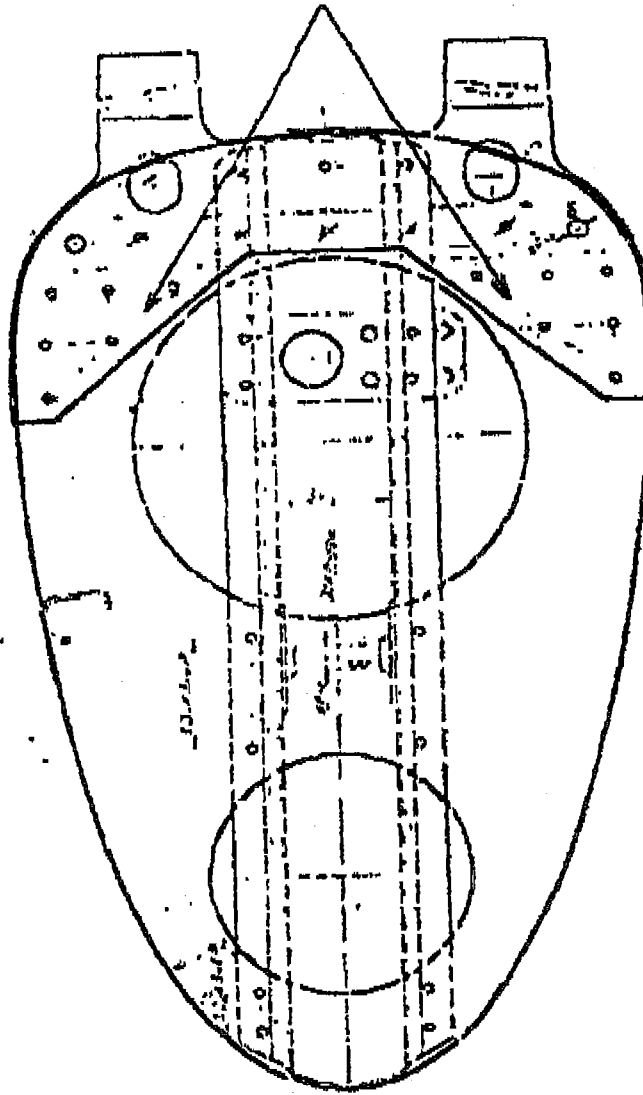
Fig. 2

Measuring contact point

- Fuselage bulkhead N. 14 with attachment fitting P/N  
A 102 021 N
