LUFTDYKTIGHETSPÅBUD (LDP)

AIRCRAFT BELTS - 1

99-006A KONTROLL AV SETEBELTETS LÅSEMEKANISME

98-25-10 R1 AIRCRAFT BELTS, INC.: Amendment 39-11460. Docket No. 98-SW-33-AD. Revises AD 98-25-10, Amendment 39-10936. Issued December 3, 1999.

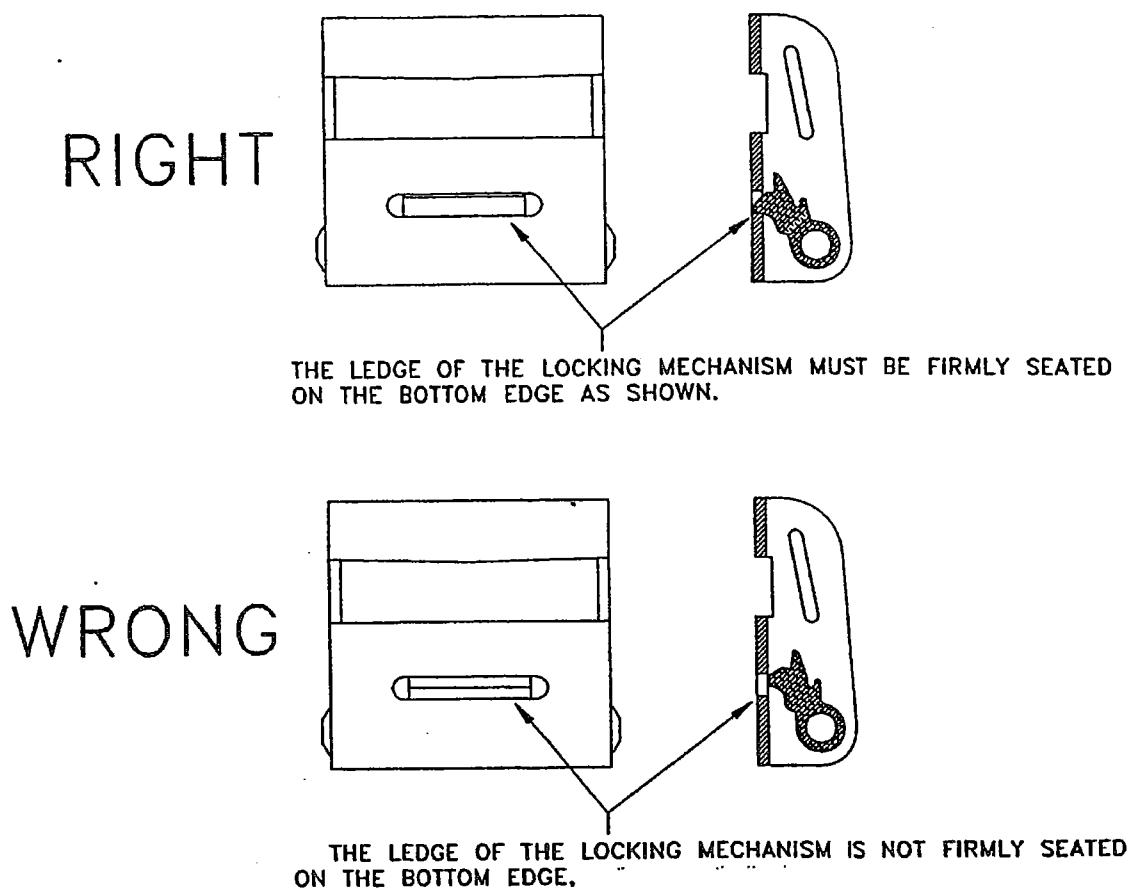
Figure 1

To prevent failure of the seat restraint system due to the buckle assembly (buckle) locking mechanism not engaging properly, which could result in the seat restraint system failing to properly secure the occupant during turbulence or landing, accomplish the following:

- (1) Open the lift lever of the buckle fully until it will not open any further. This will cause the locking mechanism to pivot on the pivot pin.
- (2) Allow the spring to close the lift lever slowly until the lift lever is back to its at-rest position.
- (3) After the lever is completely closed, examine the slot in the bottom of the buckle. The locking mechanism should be firmly seated against the edge of the slot as shown in Figure 1.

(b) If the locking mechanism does not seat properly, replace the buckle with an airworthy buckle.
