## LUFTDYKTIGHETSPÅBUD (LDP)

### 96-086 KONTROLL/UTSKIFTING AV «ENGINE OIL ADAPTER»

# AIRWORTHINESS DIRECTIVE

**96-12-22 CESSNA AIRCRAFT COMPANY:** Amendment 39-9665; Docket No. 93-CE-54-AD.

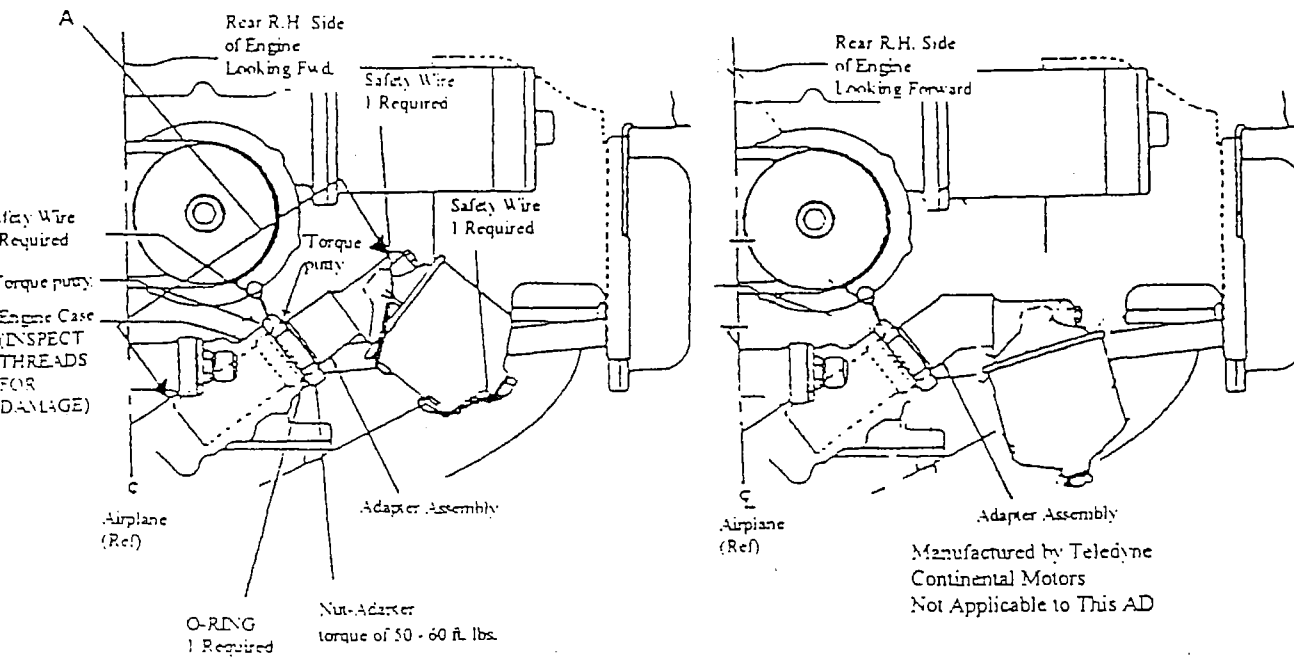
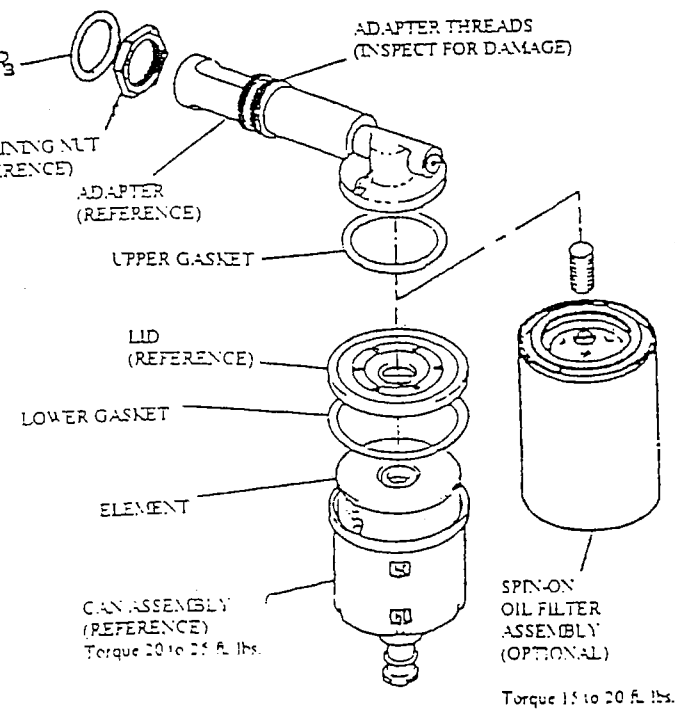
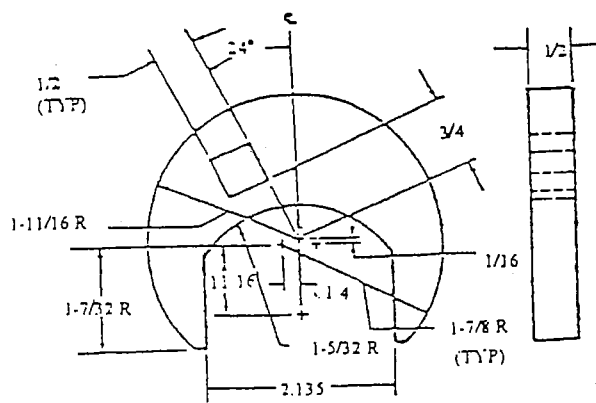
Figure 1 Oil Filter Adapter Installation

NOTE 2: This AD does not apply to engine oil filter adapter assemblies manufactured by Teledyne Continental Motors (See Figure 1 of this AD).

To prevent loss of engine oil caused by loose or separated oil filter adapters, which could result in engine stoppage while in flight and loss of control of the airplane, accomplish the following:

(4) Apply torque putty between the engine filter adapter assembly, nut, and oil pump housing as specified in Figure 1 of this AD.
