LUFTDYKTIGHETSPÅBUD (LDP)

L'HOTELLIER - 1

95-005A KONTROLL AV KULE OG «SOCKET CONNECTORS»

L`Hotellier ball and socket connectors

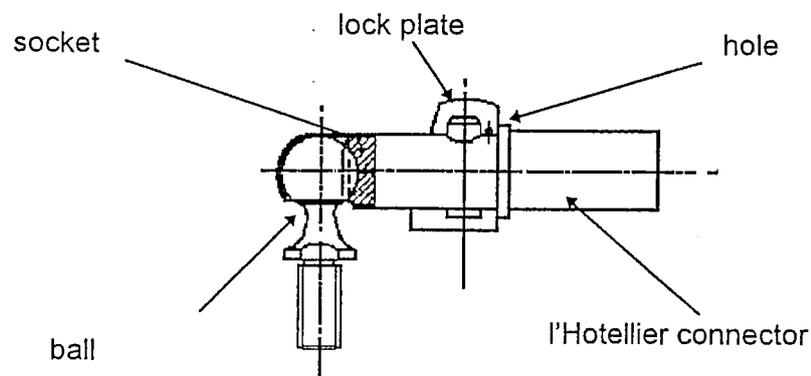
Section I

If the connectors are not yet equipped with safety pins (e.g. l'H 140-31 made by Hotellier), these safety pins have to be retrofitted. In certain cases it may become necessary to rebores the hole in the lock plate, which is provided for visual inspection, to $\varnothing 1.2$ mm so that the safety pin can be inserted.

Unsecured ball and socket connectors may open automatically in flight!

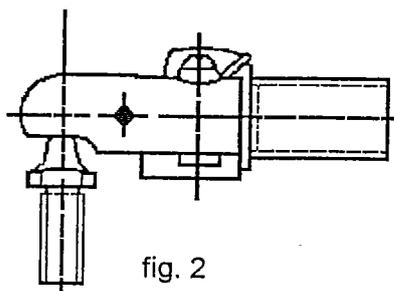
fig. 2

The following systems to secure l'Hotellier ball and socket connectors are LBA-approved: Uerlings sleeves or Uerlings type sleeves (see section III), safety pin (figures 2 and 2a), LS-safety sleeve (figure 3), Schempp-Hirth spring (figure 4) und Wedekind locking system (figure 5).

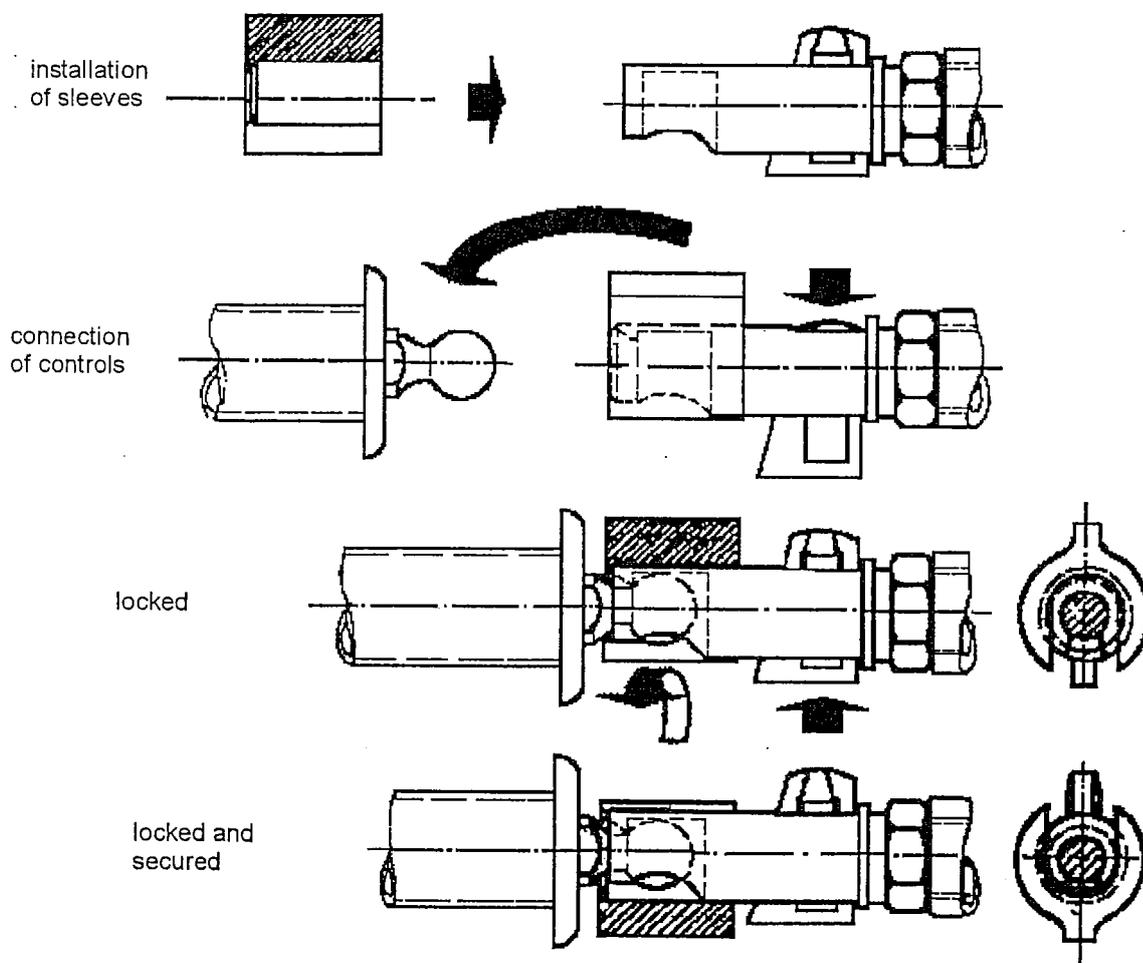
Section III

They may by no means be clipped radially onto the l'Hotellier ball and socket connector. Radial clipping (excessive opening of the sleeve) may lead to cracks or ruptures due to overstressing so that the sleeve cannot function properly any more.

For installation, the sleeves have to be slid axially onto the l'Hotellier ball and socket connectors.

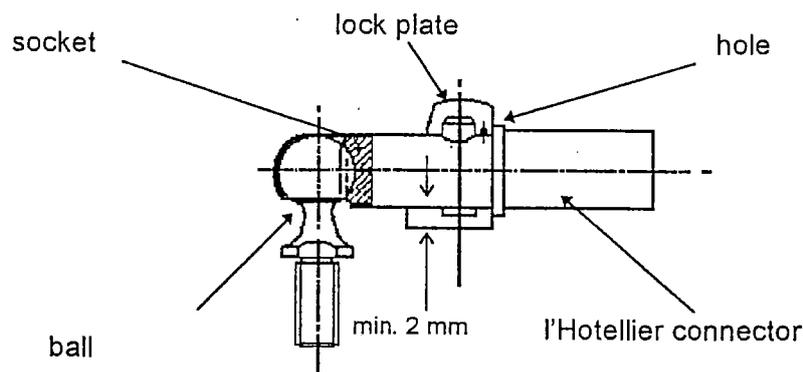
Section IV

The socket is to be slid completely over the ball with the lock plate pressed down. During locking the lock plate moves back slightly so that in a correct connection the hole on the narrow edge of the lock plate becomes visible.

Unsecured ball and socket connectors may open automatically in flight.

The safety pin is to be inserted in this hole thus securing the ball and socket connector.

By loading the connection full engagement of the ball is to be verified!

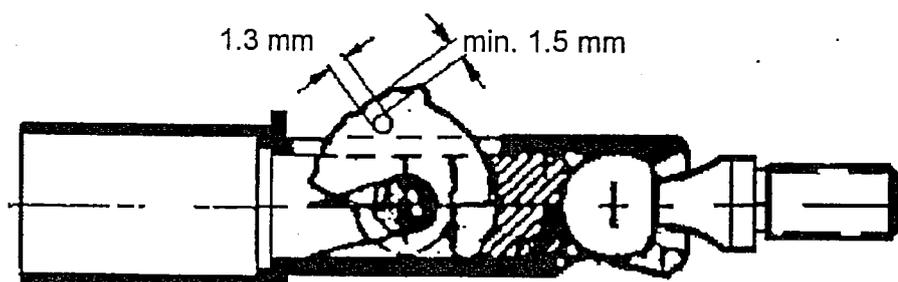
Section II

When working on the connector, please see to it that no borings get in between the ball and the socket.

Drill the hole \varnothing 1.3 mm with the ball correctly inserted so that one edge of the hole is level with the main body of the connector and on the other side at least 1.5 mm of material is left (see also the following sketch).

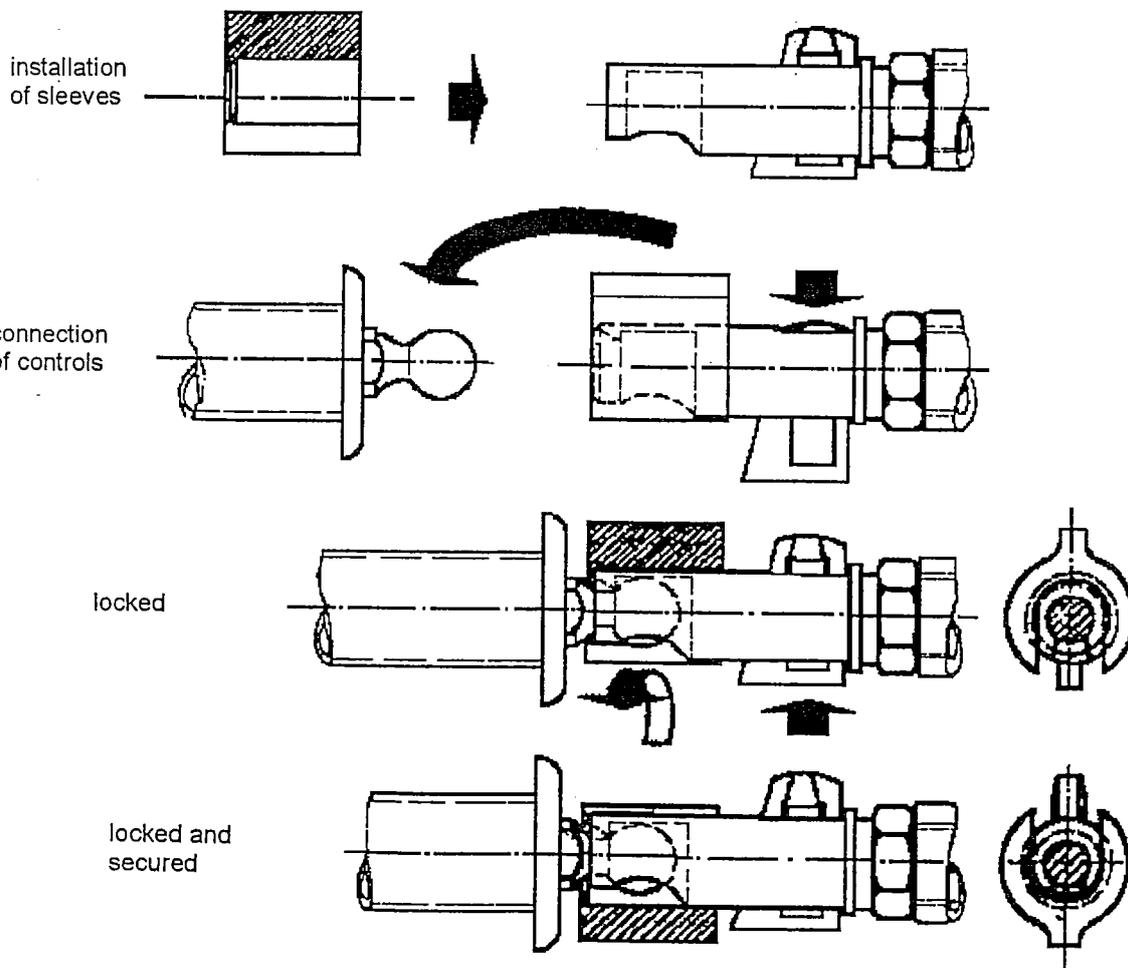
Section III

They may by no means be clipped radially onto the L'Hotellier ball and socket connector. Radial clipping (excessive opening of the sleeve) may lead to cracks or ruptures due to oversteering so that the sleeve cannot function properly any more.

For installation, the sleeves have to be slid axially onto the L'Hotellier ball and socket connectors.
