LUFTDYKTIGHETSPÅBUD (LDP)

Tilbehør
Pacific
Scientific-1

15/80 KONTROLL OG UTSKIFTING AV SETEBELTELÅSER

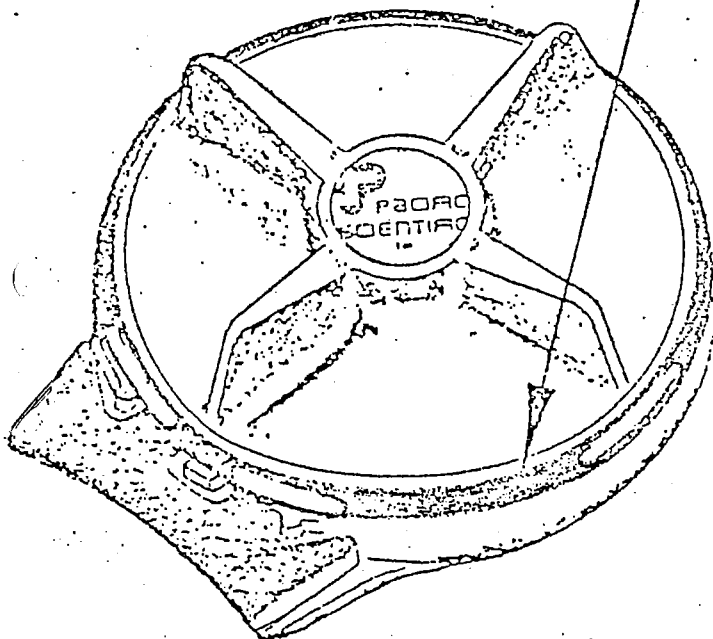
Ny type Body Plate med
sort skive

Kontroller om låsen har en sort plate under utløserplaten som vist på på skissen. Derom ingen sort plate finnes, skal beltelåsen skiftes ut med ny påmontert sort plate eller så skal hele beltet skiftes ut.

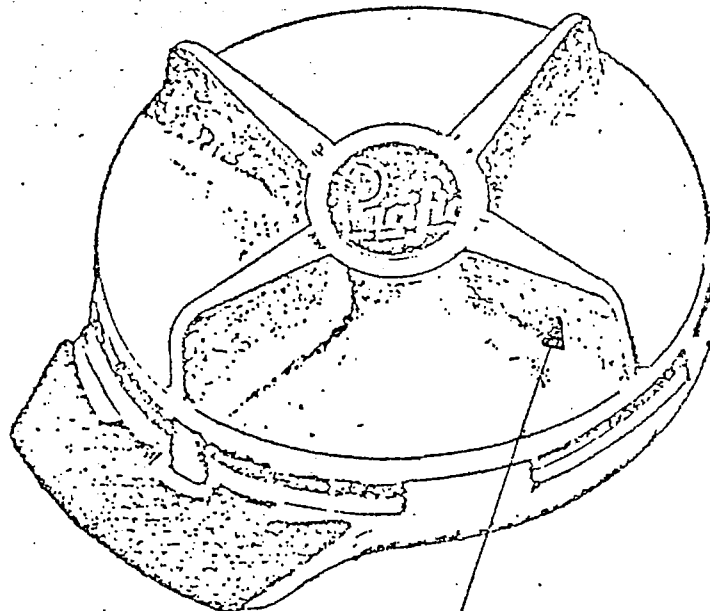
Gammel type

(Kan også ha to blad istedet
for fire)
